Ballyhaunis Swimming Pool

Co. Mayo

Type of Job Outdoor Swimming Pool Waterproofing

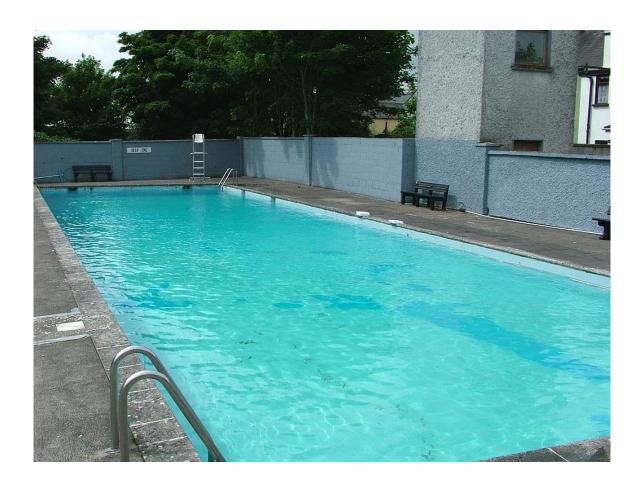
Products Maxseal Flex System, Concreseal Plastering, Maxsheen Pool

As this was an outdoor swimming pool and the structure was built into the ground, it was critical to success of the project that a waterproofing system, which is capable of offering protection against both positive and negative water pressure, was installed. To provide this the Drizoro Waterproofing System were specified for use.

Maxseal Flex, a flexible cementitious waterproof coating, is suitable for both positive and negative water pressure. Maxseal Flex was used to provide a Type A (Barrier Plastering Protection) System as described in BS8102: 2009 to the complete structure.

Concreseal Plastering was applied as a protection layer over the waterproofing.

Maxsheen Pool was then applied as decorative coating to inhibit the formation of algae, fungus, lichen etc., whilst the pool is empty during the winter months.
